RE: Cross Lake Water Quality Improvements – Phase 3
Technical Summary Memo
Crosslake, MN

Project Summary

Crosslake Water Quality Improvements Phase 3

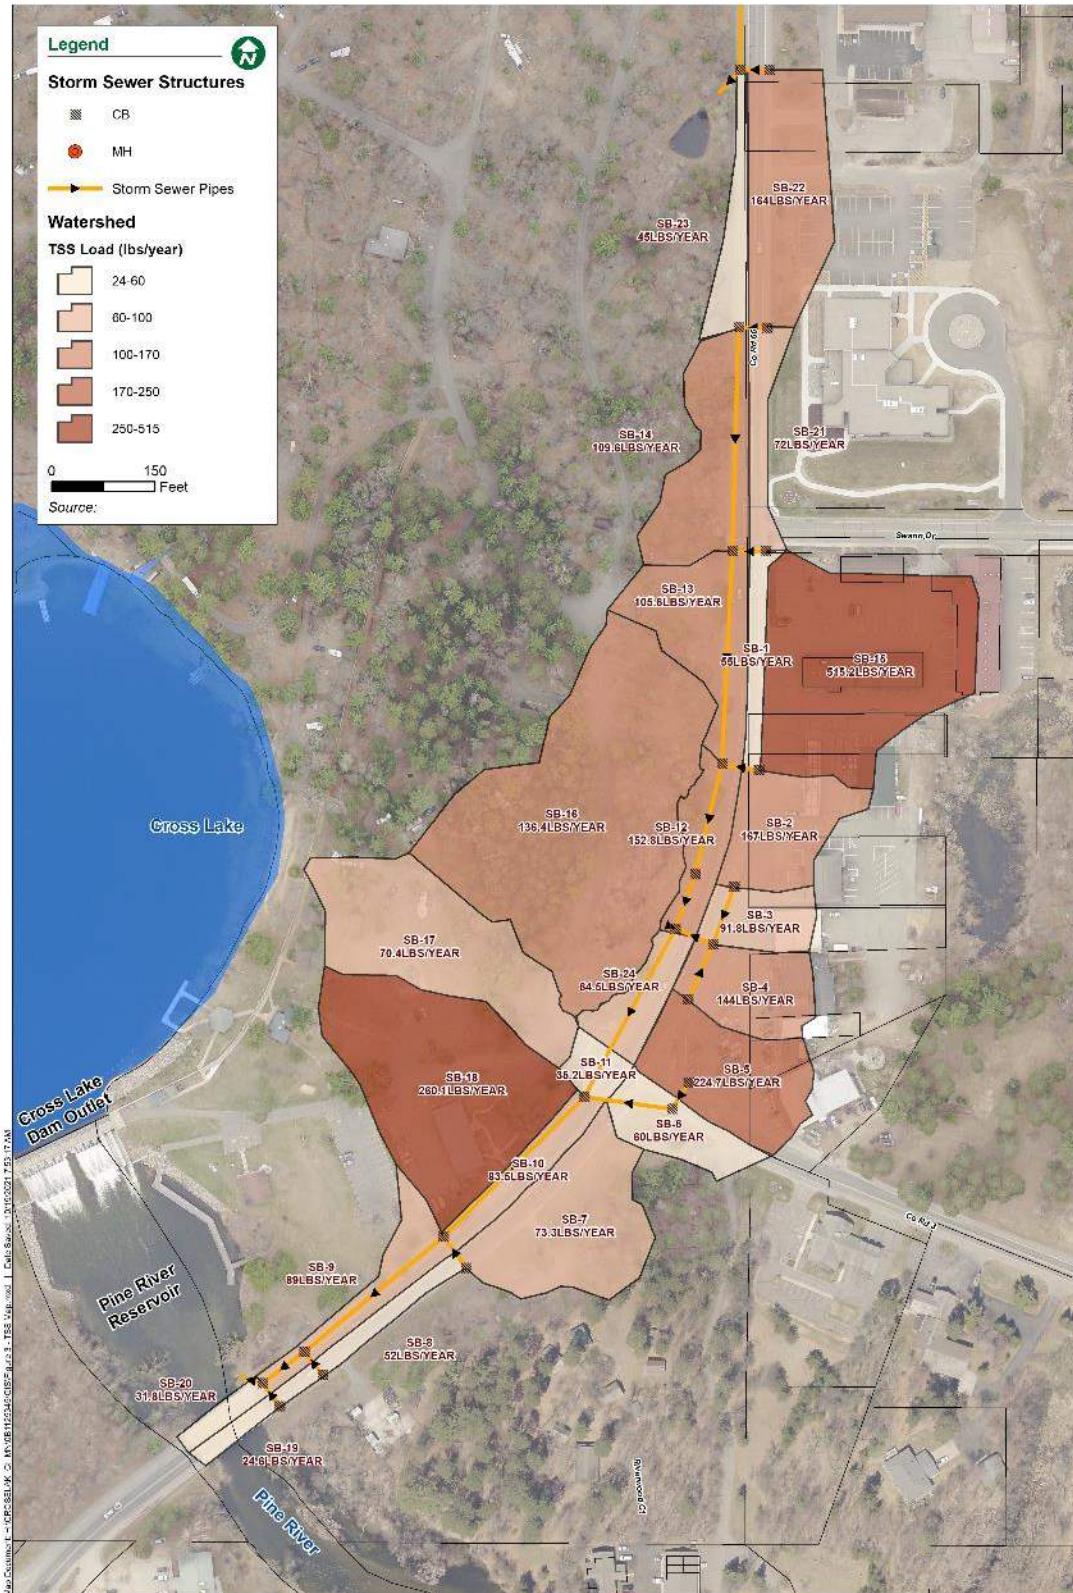
Figure 3 - TSS Map

Using SHSAM, each subwatershed was assessed for total suspended solids loading. **Figure 3** displays the regional variation of anticipated sediment loading based on the models input. These inputs include:

- Drainage area.
- Percent impervious area.
- Flow path length (hydraulic length).
- Average percent slope.
- Pervious area curve number (61 for all analyses).

Since SHSAM relies on standard particle size distributions to determine TSS removals and not EMCs, the standard particle size distributions were not modified based on the sampling results. Furthermore, since the sample results were variable across the respective flow regimes during sampling, the averages do not provide enough statistical correlation to the MCPA's more conservative average to warrant modifying the EMCs.

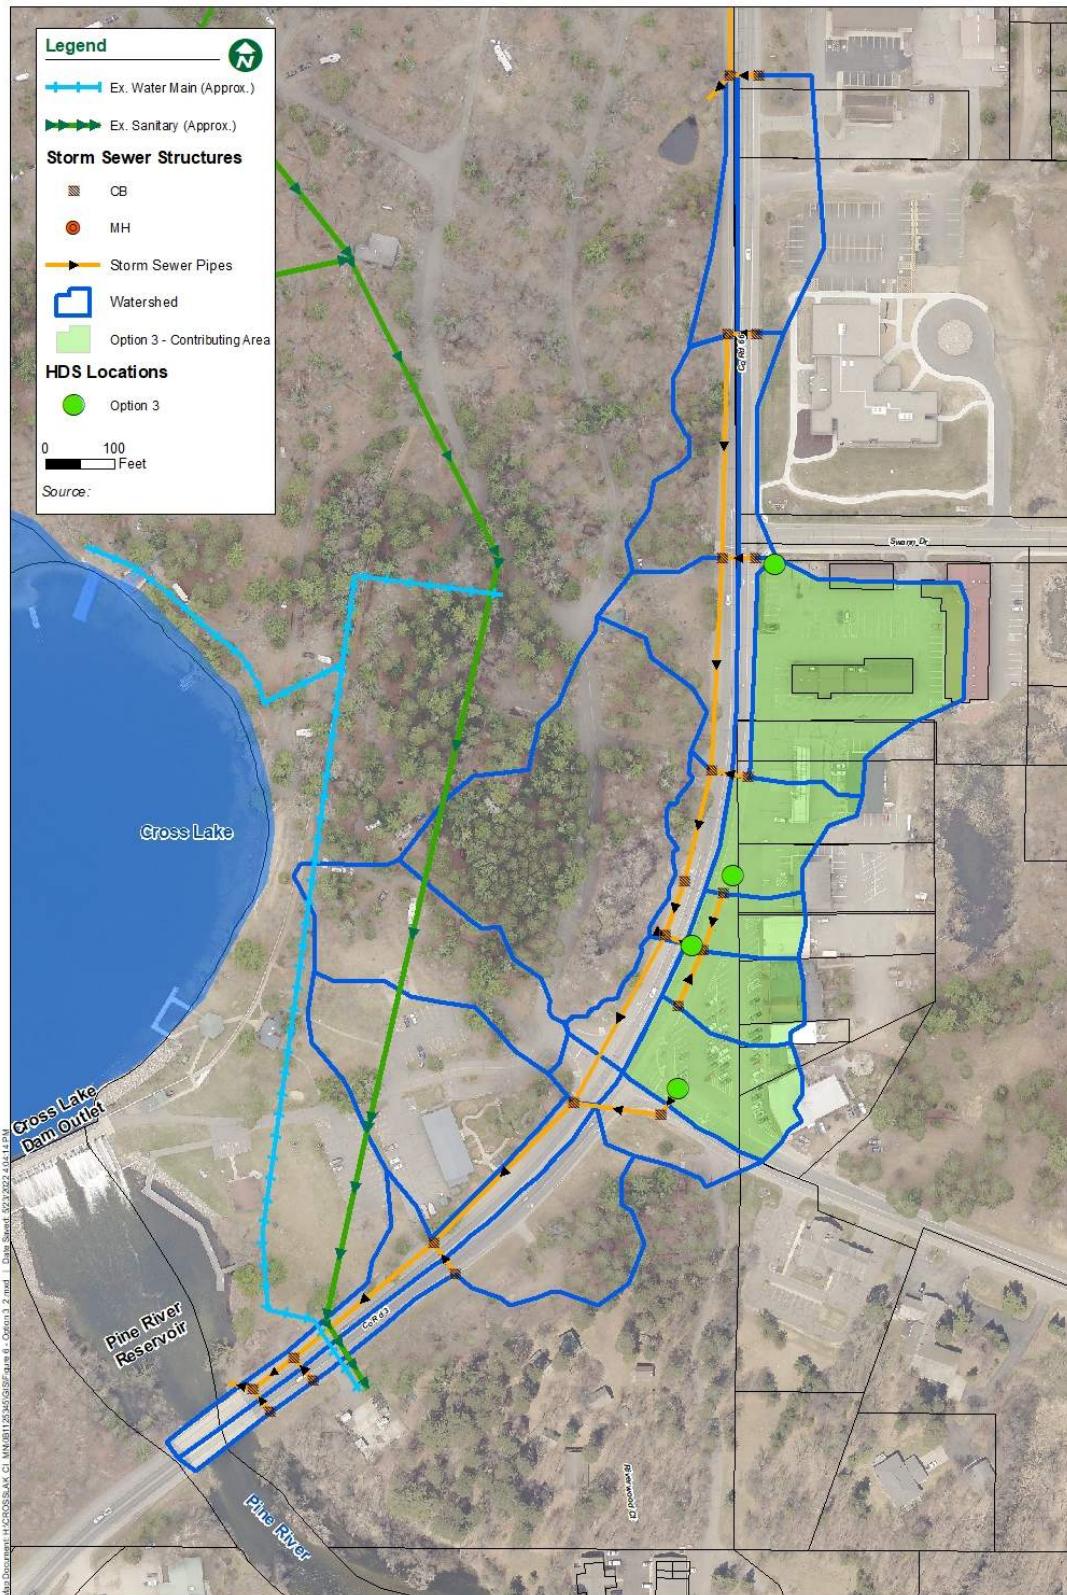
Figure 6 - Option 3

Option 3 consists of four stand-alone structures on the east side of the roadway corridor, as shown in Figure 6, which will target the runoff coming from the local and commercial businesses. This is the highest concentration of impervious area. This option requires four 5-ft deep, 4-ft diameter structures that would treat nearly four acres of impervious area. Although slightly more expensive than Option 2 in terms of structure costs, Option 3 provides the best access for maintenance and lowest potential impact to traffic during both construction and maintenance. At the same time, Option 3 achieves similar percentages of retained sediment. Table 5 shows the water quality improvements for Option 3 and Table 6 shows the preliminary cost estimate.

- Option 3 would be the second most effective solution; however, we would be missing out on the treatment of runoff from the roadway. The cost per pound removed for Option 3 and Option 4 are essentially the same.
