Minnesota
F-29R(P)-28
Study 3, Job 4
Area F212

**MISSISSIPPI RIVER SURVEY REPORT
BRAINERD FISHERIES MANAGEMENT AREA
CROW WING COUNTY, MINNESOTA**

Owen E. Baird
Minnesota Department of Natural Resources
Section of Fisheries Brainerd, Minnesota
March 2009

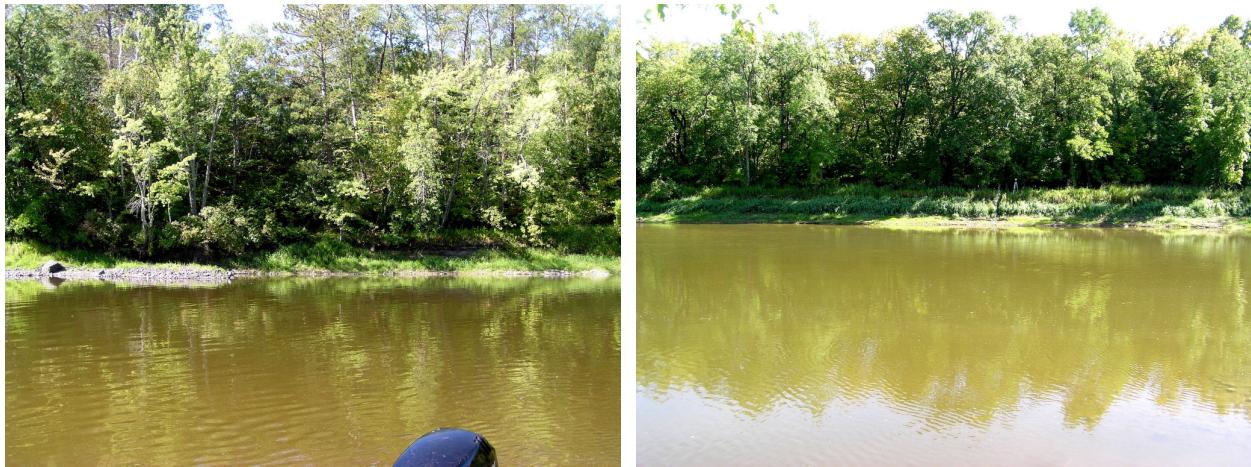
Figure 2. Images of channel survey site 29-7 at the cross section location. Left image is looking at the left bank and right image is looking at the right bank.

The survey site in reach 29 was slightly entrenched with a moderately high width to depth ratio resulting in a C4c- channel classification (Table 4). The left bank was against the valley wall while about 800 ft of flood prone area was present on the right bank (Figures 2, 3, and 9). The bed particles were a mix of silt, sand, gravel, with a few boulders with gravel as the median particle size. The water surface slope was low at 0.00012. This reach had the tightest average radius of curvature at 390 ft. The surveyed cross section in reach 29 appears to be representative of most of the reach. Some relatively small areas with more abundant large cobble and boulder are present within the reach.

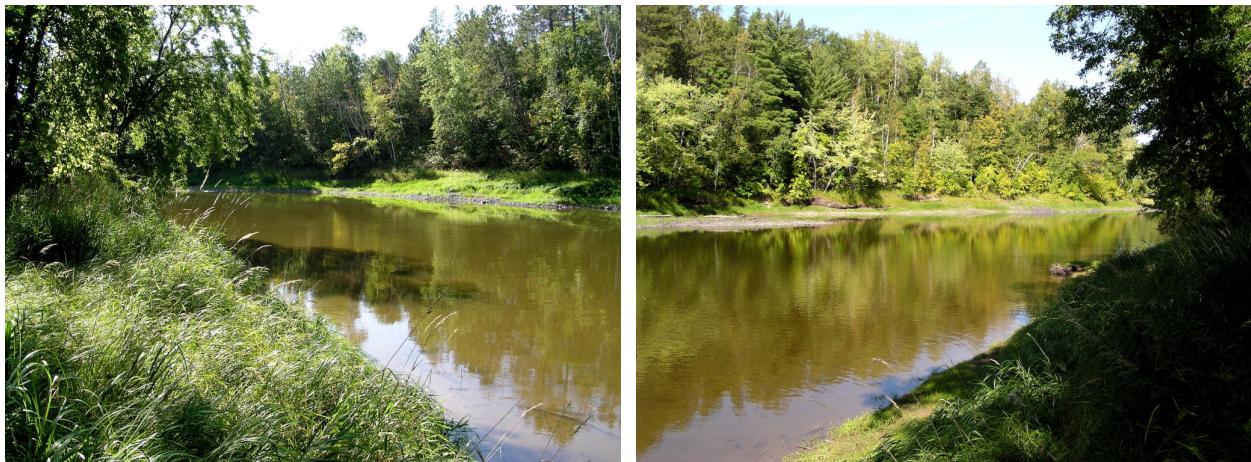
Figure 3. Images of channel survey site 29-7 looking upstream (left image) and downstream (right image) from the right bank at the cross section location.

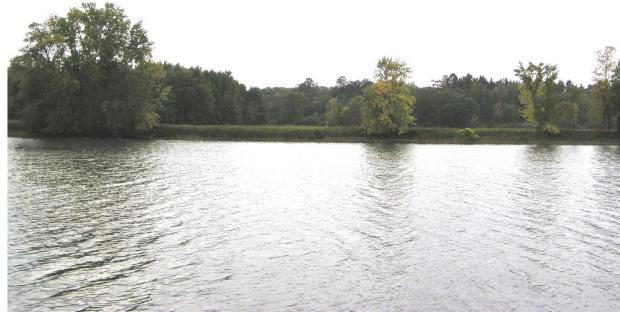
Figure 4. Image of the left bank at channel survey site 30-16 at the cross section location.

The survey sites in reaches 30 and 31 are impounded by the Brainerd Dam and so were not classified because they are not free-flowing channels (Table 4). At both sites wild rice and other aquatic vegetation was abundant in the shallow water along the banks (Figures 4-6). In reach 30, the water elevation was close to the estimated bankfull elevation (Figure 10). A wide floodprone area resulted in the highest entrenchment ratio. The actual flood prone elevation is likely much lower than the estimated twice maximum bankfull depth as the bankfull elevation is influenced by the Brainerd Dam. Reach 30 had the greatest meander belt width and meander wavelength of the five reaches. The lowest measured water surface slope was at site 30-16 (0.00008). The upper approximately one to two miles of reach 30, immediately below the confluence with the Pine River, tends to be more riverine than the remainder of reach. How much of the upper portion of the reach that is more riverine and how much is influenced by the Brainerd Dam depends on the river discharge. A low discharge, the free flowing section extends further, up to about 2 miles below the Pine River, than at high discharge.

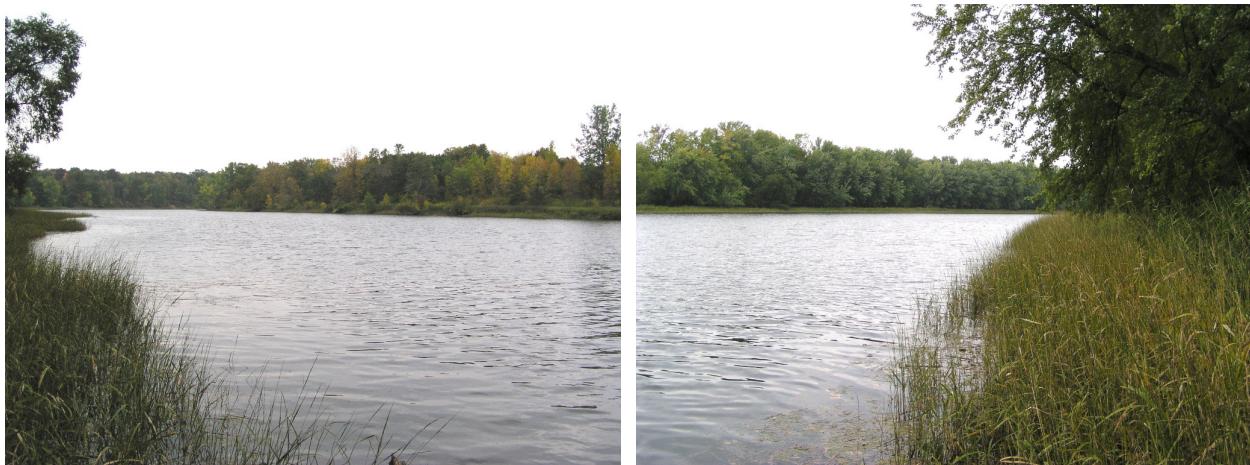
Figure 5. Images of channel survey site 30-16 looking downstream (left image) and upstream (right image) from the left bank at the cross section location.

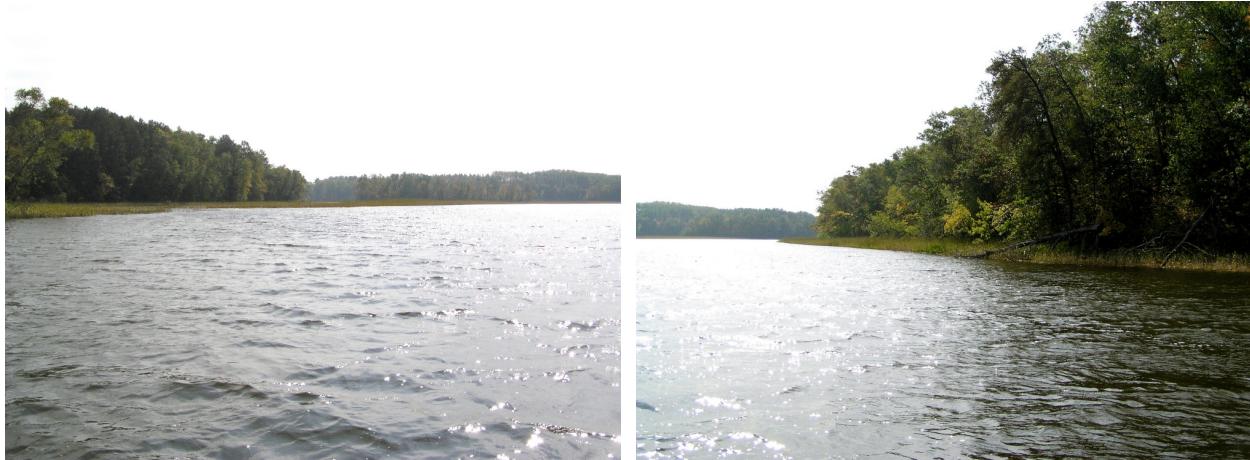
Figure 6. Images of channel survey site 31-22 looking downstream at the left bank (left image) and downstream at the right bank (right image) through the cross section survey location.

Reach 31 is the main portion of the Brainerd Dam reservoir. Some of reach 31 has much more extensive backwater areas than the surveyed cross section, which included a small section of backwater on the left bank (Figures 6 and 11). In some areas of this reach, impounded backwaters are up to about 0.5 miles wide. At French Rapids the channel is much narrower (~ 250 ft) with a limited flood prone area. While not measured, water surface slope in reach 31 is likely even lower than that found in reach 30. In reach 31, the water elevation was estimated to be similar to the bankfull elevation (Figure 11). The actual flood prone elevation is likely much lower than the estimated twice maximum bankfull depth as the bankfull elevation is influenced by the Brainerd Dam.

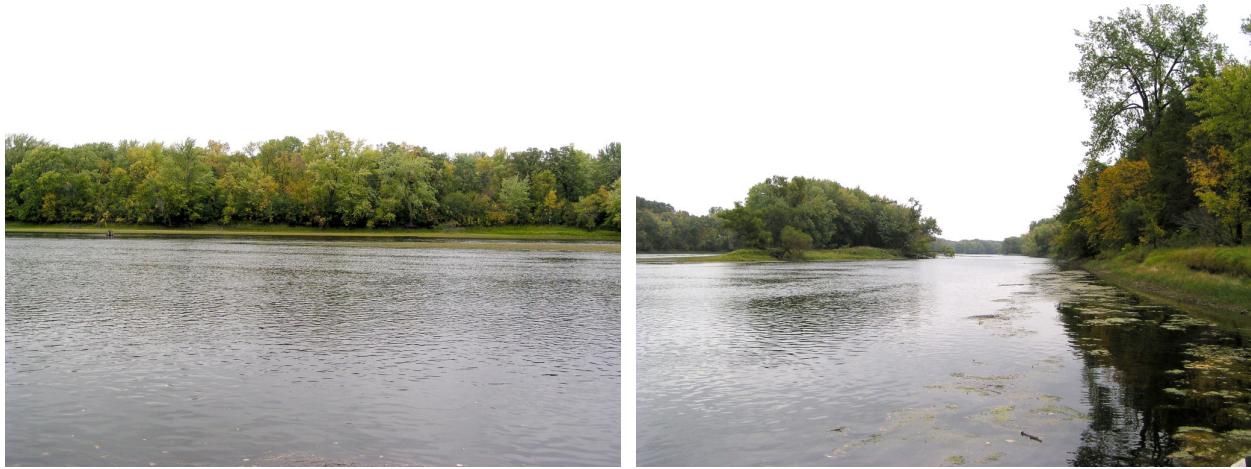
Figure 7. Images of channel survey site 32-26 looking at the right bank at the cross section survey location (left) and upstream from the left bank at the cross section survey location (right).

The two reaches below the Brainerd Dam were slightly entrenched and had very high width to depth ratios resulting in D5 (reach 32) and D4 (reach 33) classifications (Table 4, Figures 7, 8, 12, and 13). There are about 10 islands with multiple channels in the reach below the Brainerd Dam. The surveyed portion of the reach 32 was almost entirely a sand bed. The lower approximately 1 mile of reach 32 where four bridges cross the river has a higher gradient, narrower channel, coarser bed particles, and portions have a limited flood prone area compared to the section above the bridges.

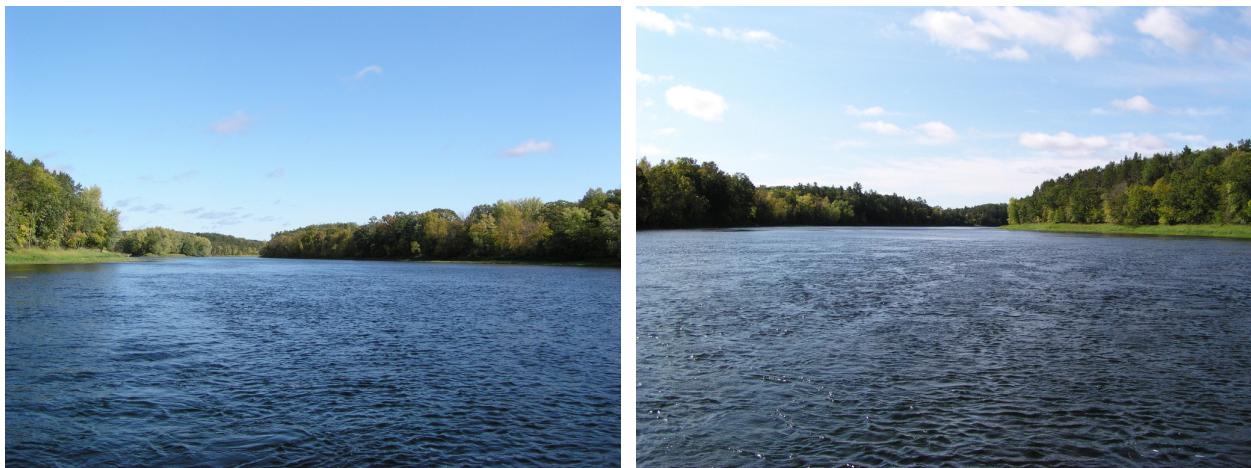
Figure 8. Images of channel survey site 33-30 looking upstream (left) and downstream (right) through the cross section survey location.
