## Northland Arboretum – Paul Bunyan Conservation Center: Rain garden

Eleanor Burkett, U of MN Extension, (888)241-0720, [burke044@umn.edu](mailto:burke044@umn.edu)

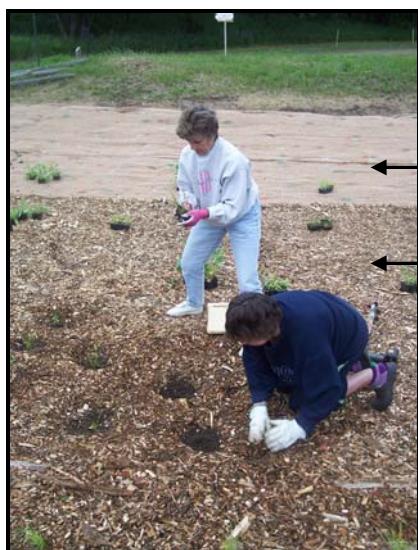
### Planting

- Hillside berm with erosion control blanket
- Level bottom with wood mulch

The predominant soil type at this site is sand/gravel. Plant survival during drought periods was a concern due to the poor moisture holding capacity of the soil. The rain garden was over-dug and 2 inches of top soil and 2 inches of compost were tilled into the top 12 inches of parent soil. After the rain garden was dug and the berms constructed, coco fiber erosion control blanket was fitted over the berms and on the hillside slope (to prevent erosion).

The base of the rain garden was covered with 2" of wood mulch (to aid in moisture retention). Then 760 plants were planted. Cost for plants and materials (erosion control blanket and stakes) were approximately \$1,200.00. Wood mulch was provided by the arboretum.

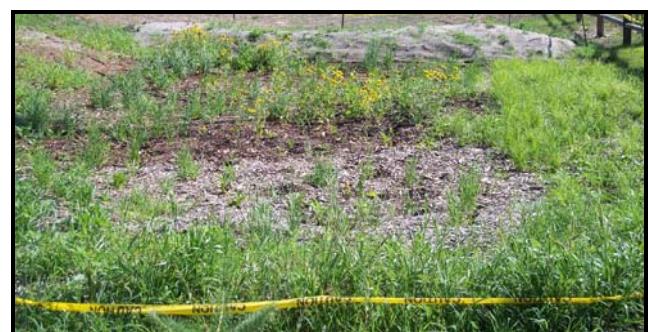
Two months after planting
