Straw or Hay Bales

Description

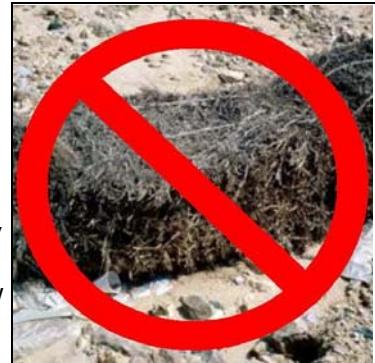
Alternatives to straw or hay bales should be used wherever possible
